# PARMER LANE FIRE CASE STUDY

## Incident Summary:

The Parmer Lane Fire began on August 8, 2023, in Cedar Park, Texas at approximately 6:00 p.m. This wildfire caused the evacuation of 395 residences and multiple businesses. The wildfire resulted in the complete loss of one apartment building with three other apartment buildings damaged.

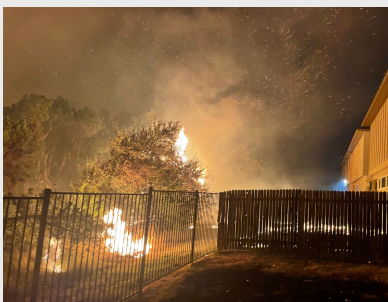
### Burning juniper with ember shower

Due to low live fuel moisture and extended drought, most vegetation in the fire fully consumed. This created a large amount of embers, which, along with the embers from the burning apartment building, showered down on Whitestone Landing throughout the night of August 8th.

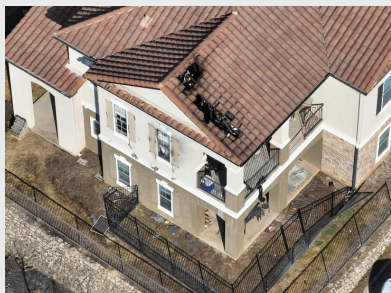
### Attic fire damage, Building 11

An attic fire was discovered in a second apartment building and was able to be extinguished before it damaged the entirety. It is suspected that embers entered the attic of both this structure and the one which was destroyed.

- Significant damage occurred where embers were able to gain access to apartment attics.

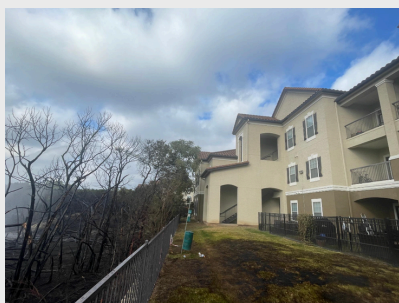
### Radiant heat damage & scorched grass

This apartment building experienced moderate damage from extreme radiant heat and embers due to an attic fire and radiant heat melting decorative vinyl up to the third floor and cracking the first pane in a bottom story window. The building has no exposed wood and limited openings into the structure.

- Limited damage was caused by the significant radiant heat from the wildfire as it approached within ten feet of buildings. This damage was contained to melted vinyl shutters and a few broken window panes on double-pane windows despite the intense, direct heat.
